AD-A155 455

| REPORT DOCUMENTATION PAGE | | READ INSTRUCTIONS<br>BEFORE COMPLETING FORM |
|--|---|--|
| 4. TITLE (and Subtitle)<br>Van Hirn Park Upper Dam<br>NATIONAL PROGRAM FOR INSPECTION OF NON-FEDERAL DAMS | | 5. TYPE OF REPORT & PERIOD COVERED<br>INSPECTION REPORT |

PHASE I INSPECTION REPORT  
NATIONAL DAM INSPECTION PROGRAM  
CONNECTICUT RIVER BASIN  
INVENTORY NO. MA 00574  
VAN HORN PARK UPPER DAM  
CITY OF SPRINGFIELD  
HAMPDEN COUNTY, COMMONWEALTH OF MASSACHUSETTS

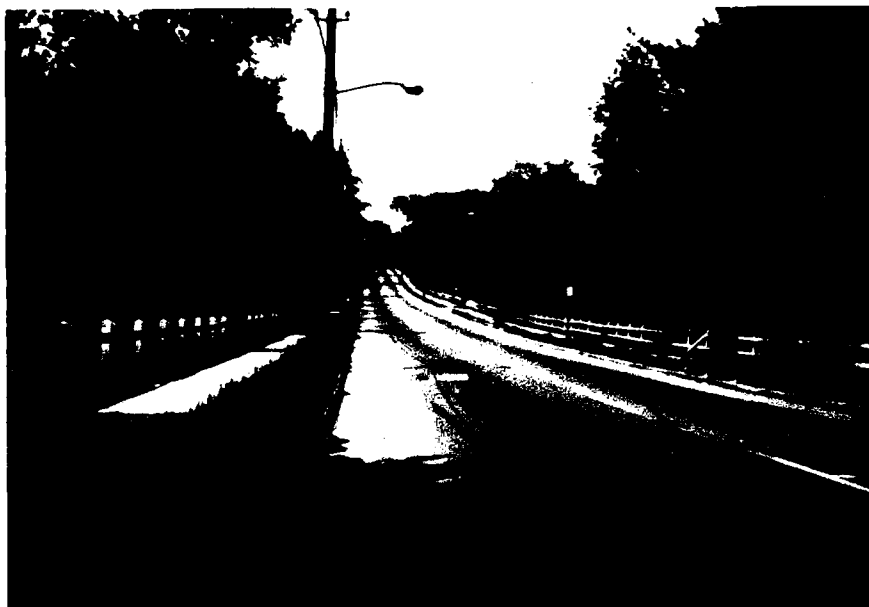
Surface Cracks asphalt pavement on crest shows longitudinal & transverse cracks in region of box culvert. Sidewalk shows evidence of minor vertical displacement

② VIEW OF CREST (ARMORY STREET) LOOKING NORTH
